REPORT NO. 2000036.401
REVISION: 0
PROJECT NO. 2000036.00
November 2020

Examination and Analysis of Equipment Involved in Mr. Justin Moore's June 8, 2017, Fall Incident

United States District Court
Northern District of Texas
San Angelo Division

Justin Moore and Judith Moore vs DB Industries, LLC, et al.

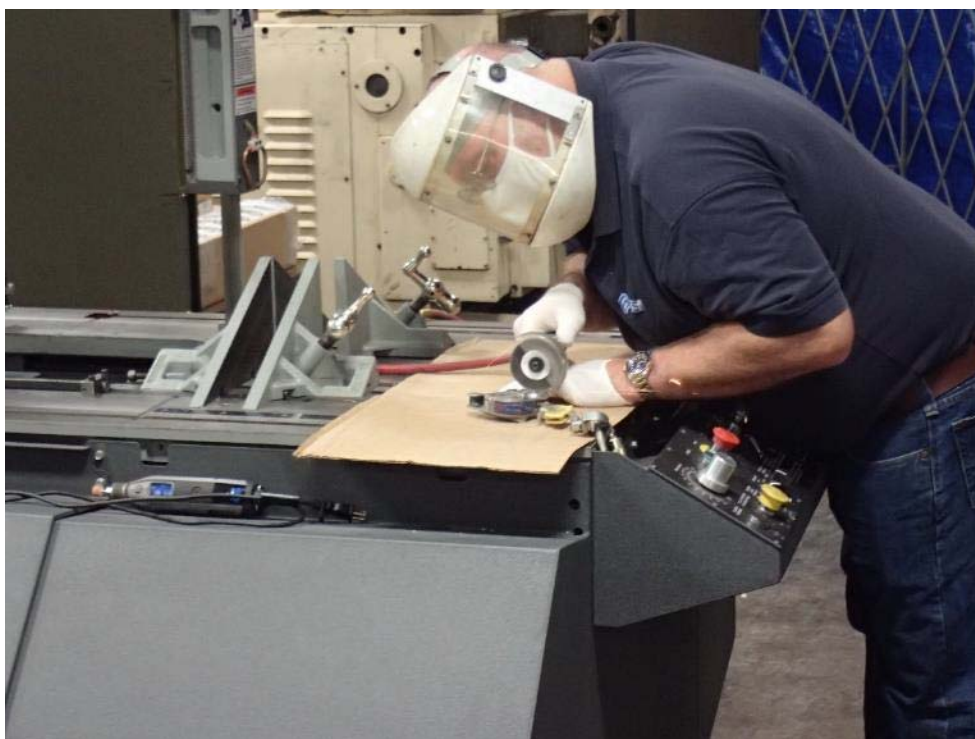
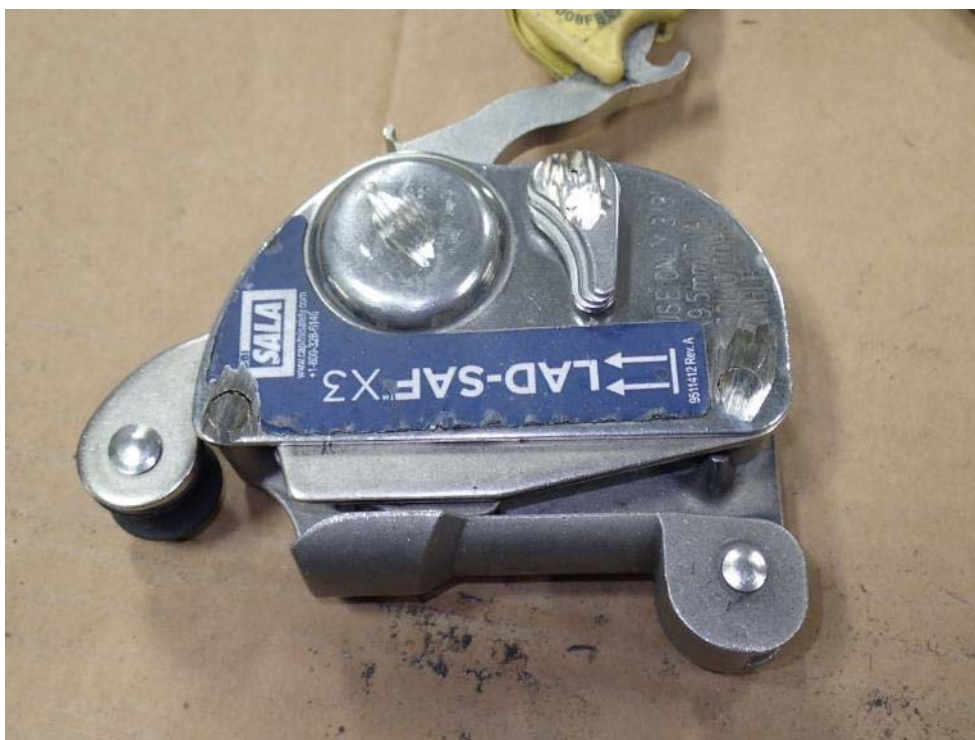
In order to further examine the individual components of the involved X3 sleeve, the rivets on one side of the device were ground off to permit disassembly of the sleeve (Figure 26). The exposed parts were removed sequentially and photographed (Figures 27 through 33). The internal parts were intact with no evidence of cracking. Small amounts of dirt or debris were observed on the surfaces of some parts, including the bushings and Teflon washer that guide the locking cam and locking arm components. The bushings also exhibited evidence of rubbing or scuffing on the edges (e.g., Figures 29 and 31). The locking cam surface that engages the cable exhibited witness marks (scuff marks or abrasions) that were consistent with the cam having engaged the cable (Figure 32).

Figure 26. Views of the subject Lad-Saf X3. In the upper image, the rivets are being ground to permit opening of the sleeve, and in the lower image, the rivets have been ground off.

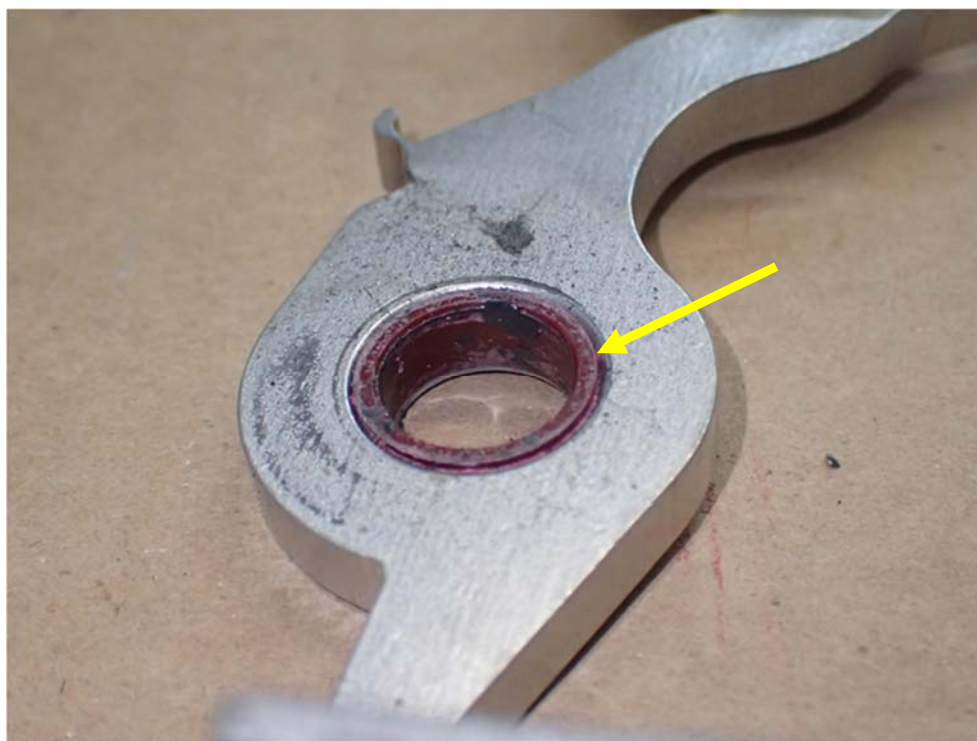
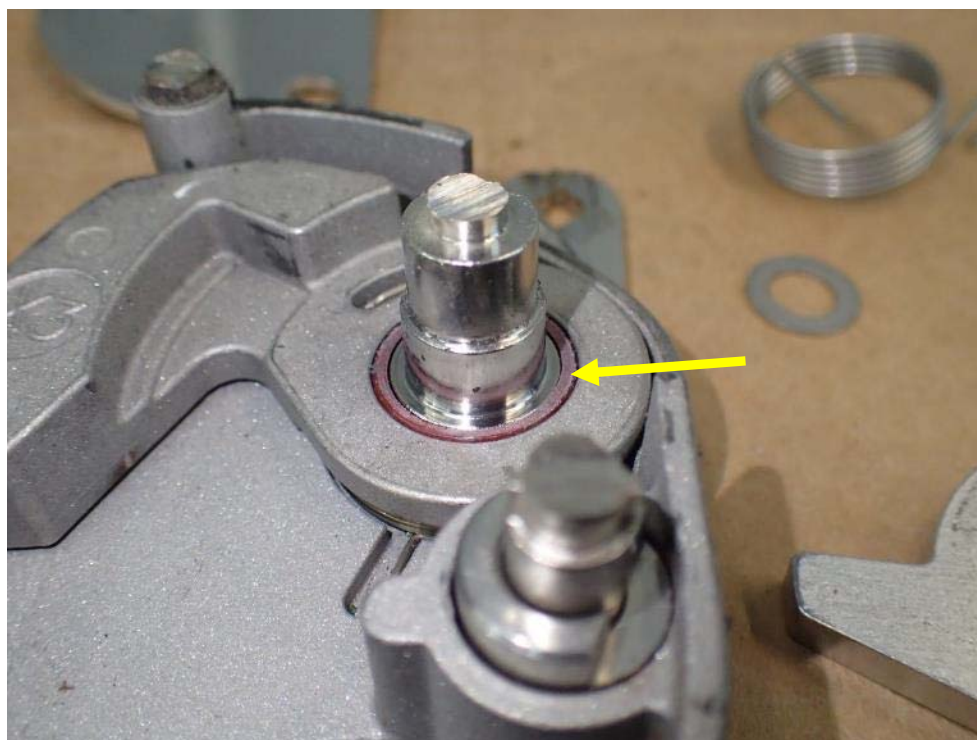
Figure 29. Additional close views of the Lad-Saf X3 components during the disassembly process. In these images, the red polymeric bushings in the energy absorber and cam are indicated by the upper and lower arrows, respectively.

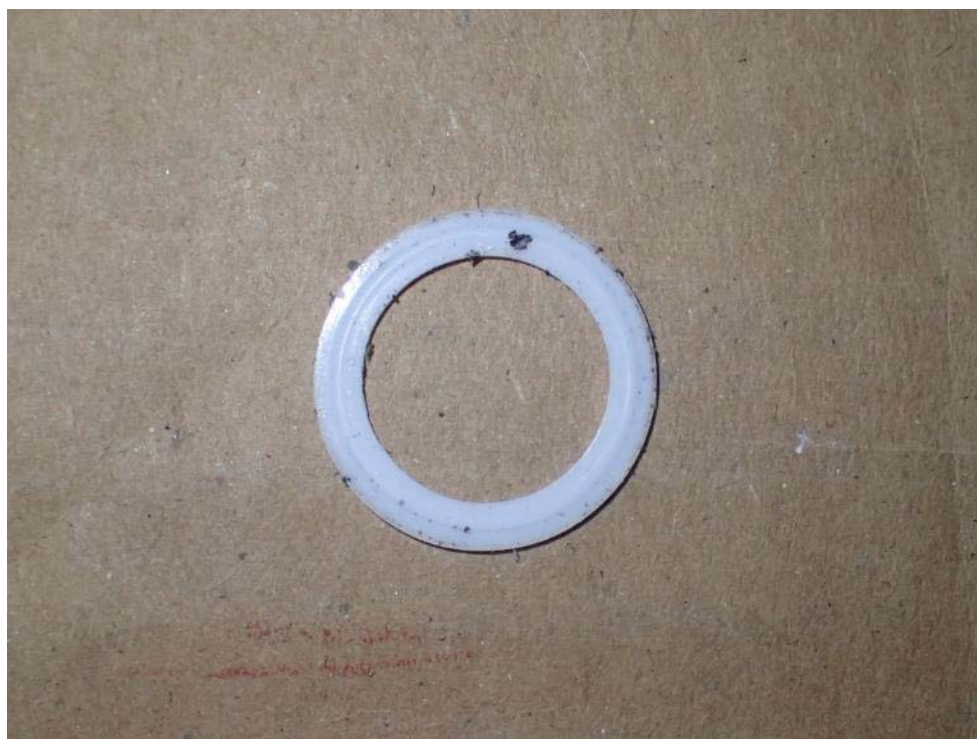
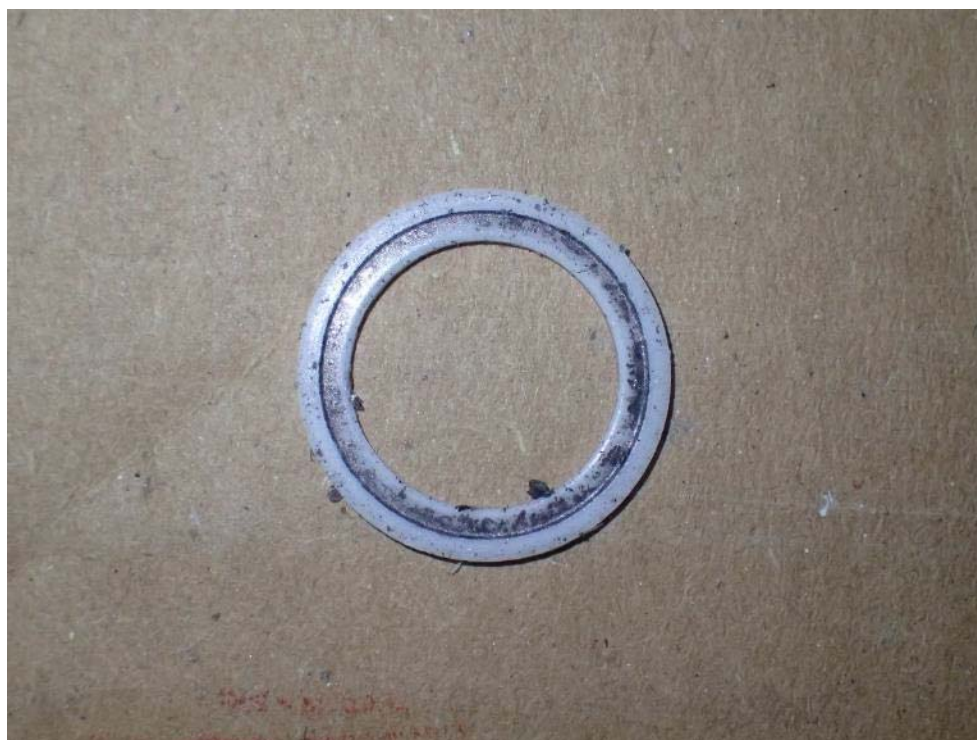
Figure 30. Close views of both sides of the polymeric washer that was installed between the energy absorber and cam bushings.

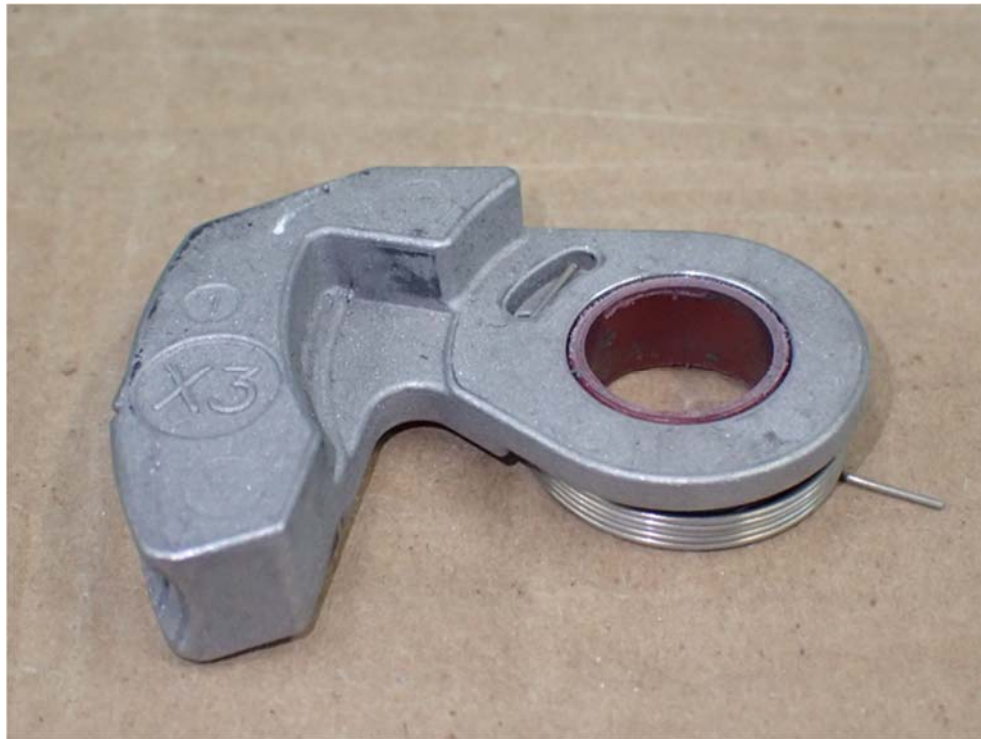
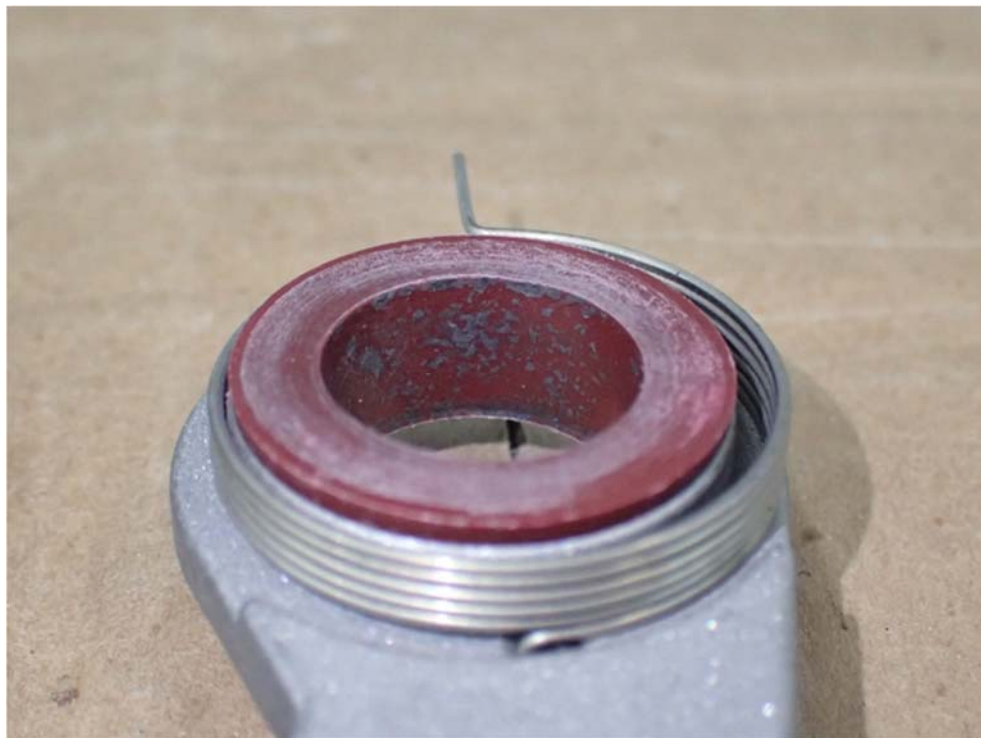
Figure 31. Close views of the cam and bushing after removal from the Lad-Saf X3.

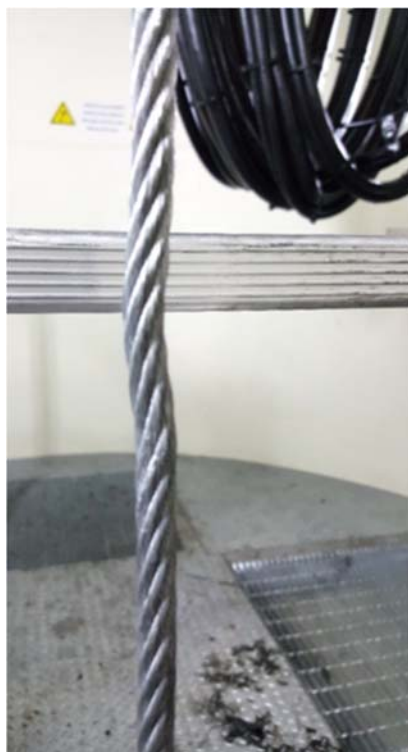
The first drop test resulted in the sleeve traveling 3.88 inches before locking on to the cable and a partial deployment of the energy absorber on the X3 sleeve that was measured to be approximately 5 inches. As a result of this test the cable was kinked in a similar manner to that which resulted from Mr. Moore's fall incident (Figure 34).

Figure 34. Views of the cable deformation produced by the first drop test performed by 3M on October 30, 2020 (upper image, provided by 3M), and the cable deformation produced by Mr. Moore's fall incident (lower image, provided by Invenergy).
